**US Army Corps
of Engineers**

USACERL Technical Report 99/36
April 1999

Ceramic Coated Piston Rods for Civil Works

The U.S. Army Corps of Engineers uses many hydraulic pistons on its Civil Works structures. Recent failures of ceramic coated piston rods in the Jacksonville District indicate that specifications for these rods need to be updated and enhanced.

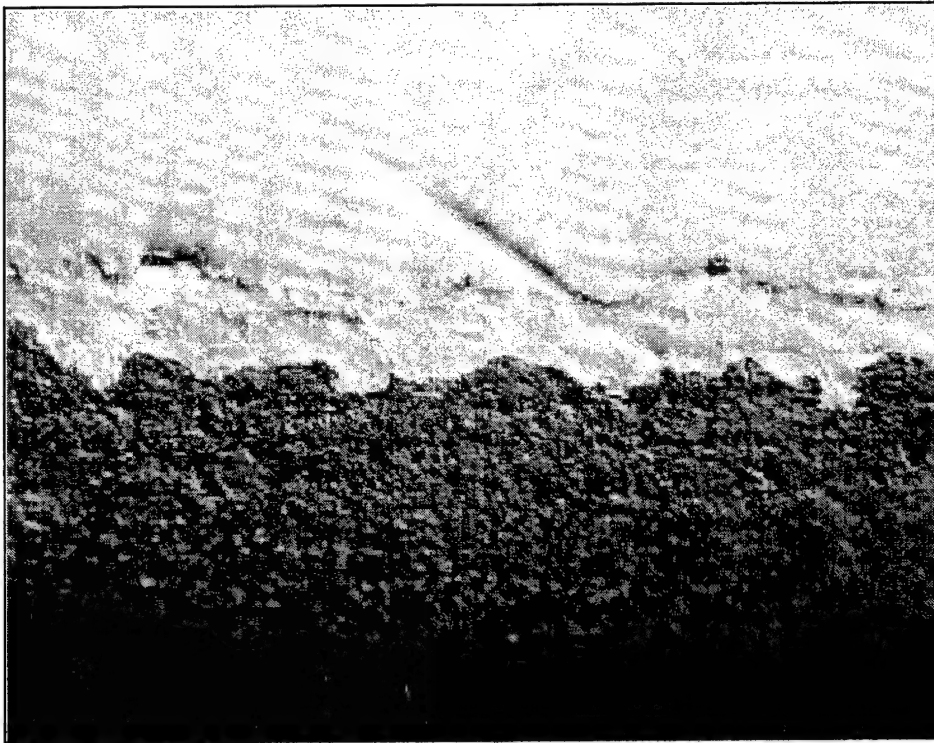
Figure 1. Cross section of alumina-13% titania coating with nickel-chrome interlayer and no seal coat (Specimen 1).

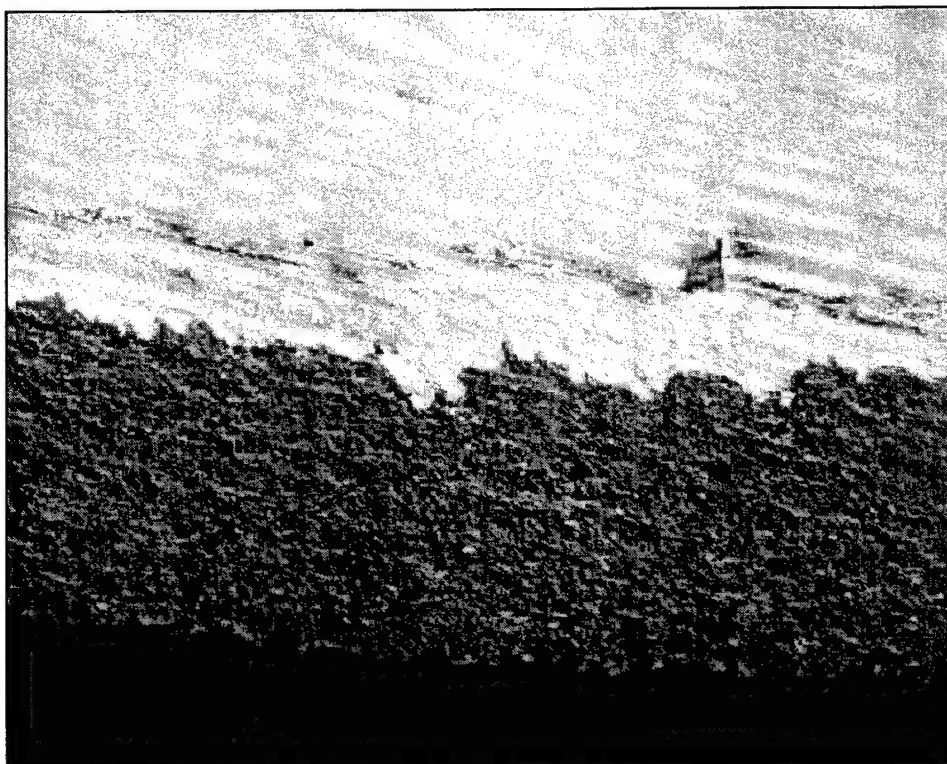
Figure 5. Cross section of alumina-13% titania coating with nickel-chrome interlayer and no seal coat (Specimen 5).

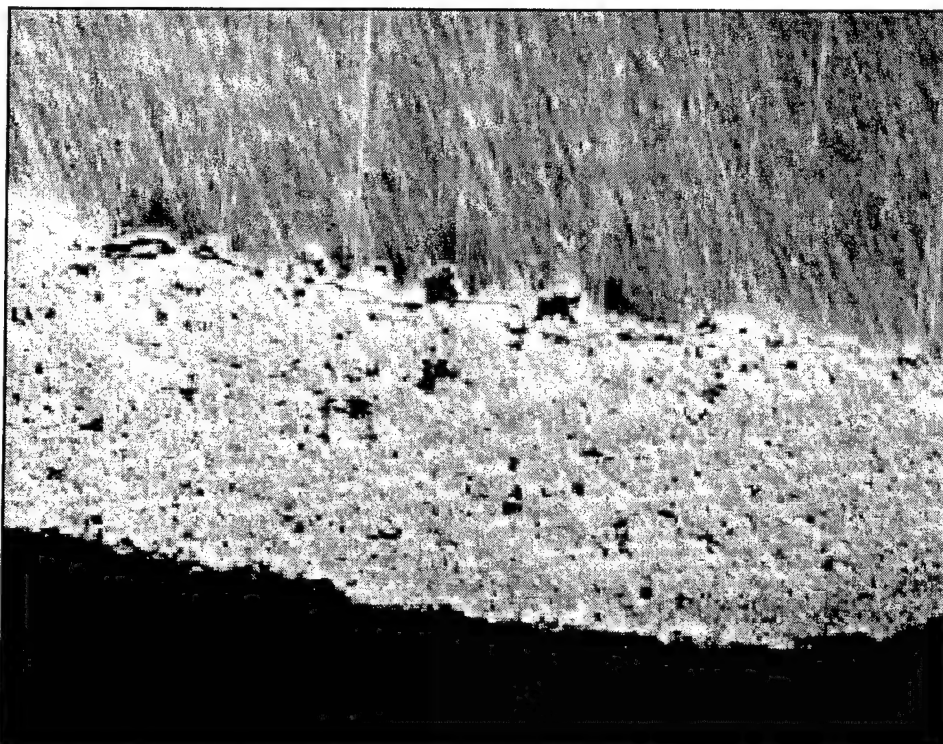
Figure 7. Cross section of chromia coating with no interlayer and no seal coat (Specimen 7).

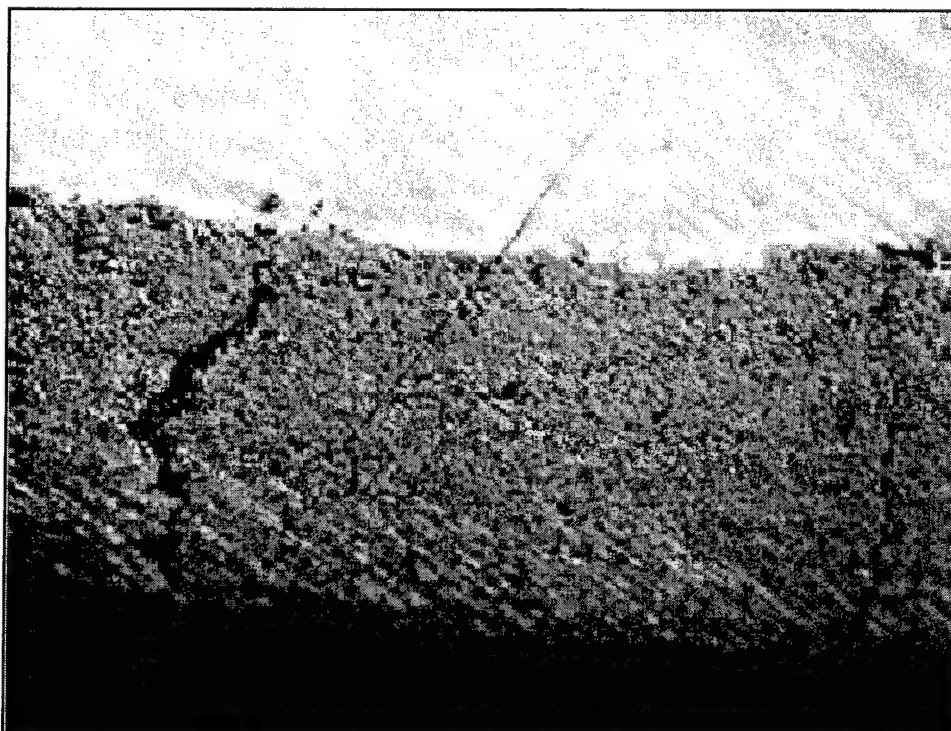
Figure 8. Cross section of chromia coating with no interlayer and no seal coat (Specimen 8).

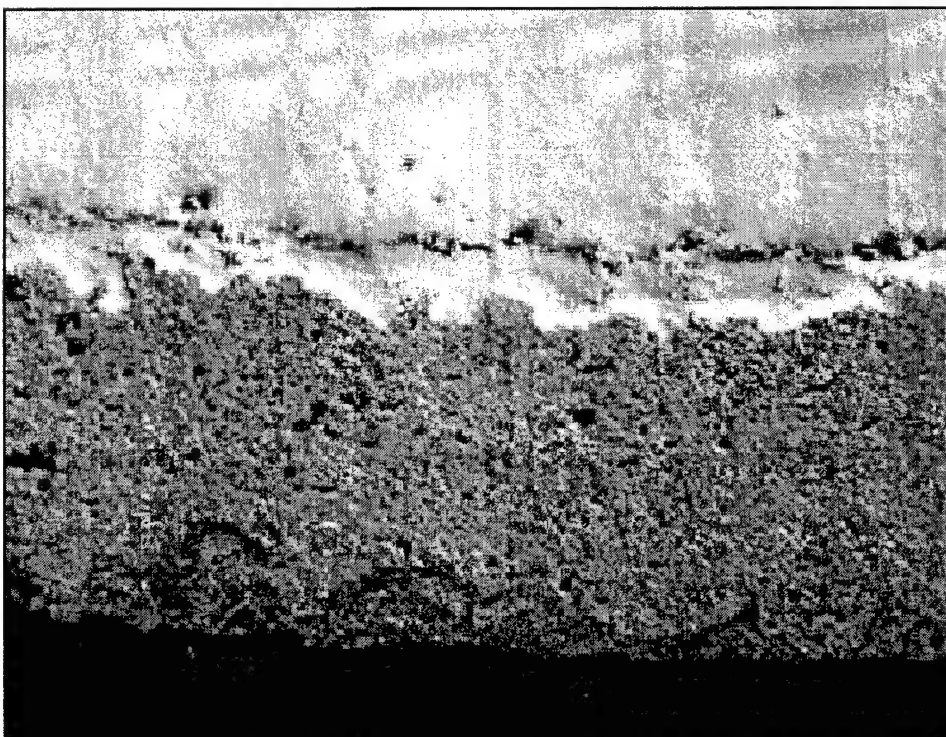
Figure 10. Cross section of chromia coating with nickel-aluminum interlayer and seal coat (Specimen 10).

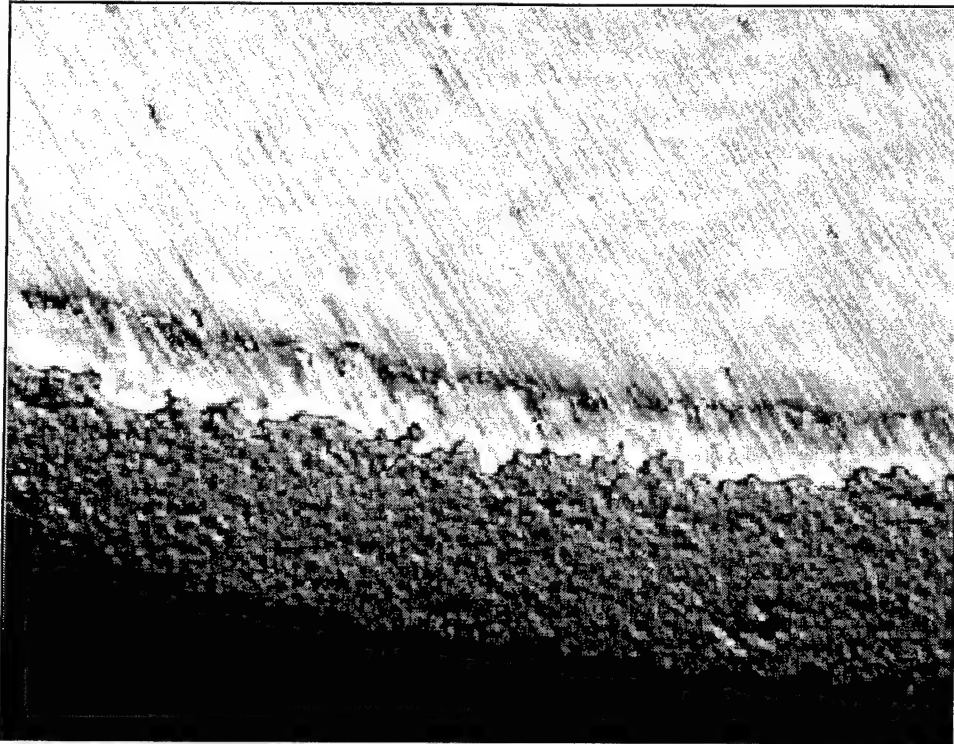
Figure 11. Cross section of chromia coating with nickel-chrome interlayer and no seal coat (Specimen 11).

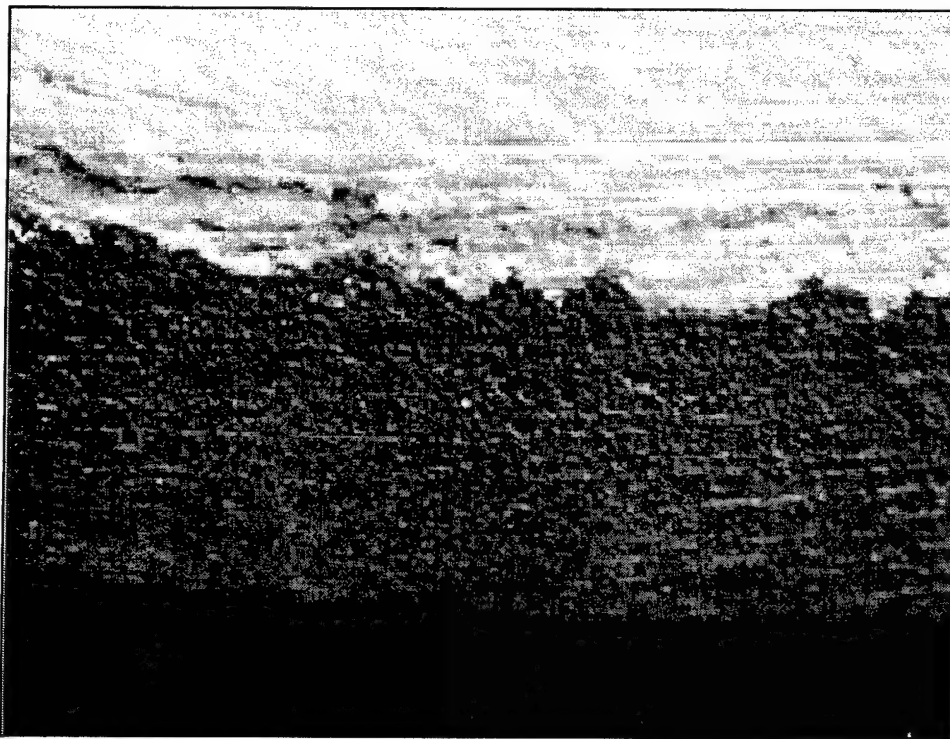
Figure 12. Cross section of alumina-13% titania coating with nickel-aluminum HVOC interlayer and no seal coat (Specimen 12).

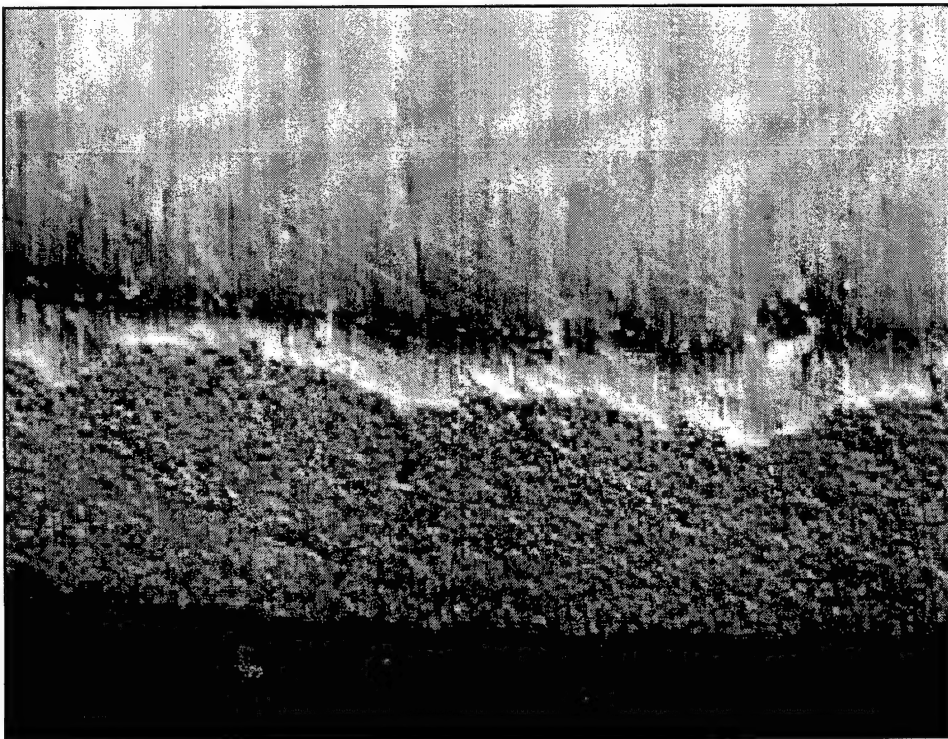
Figure 14. Cross section of chromia-5% silica-3% titania coating with nickel-chrome interlayer and no seal coat (Specimen 14).

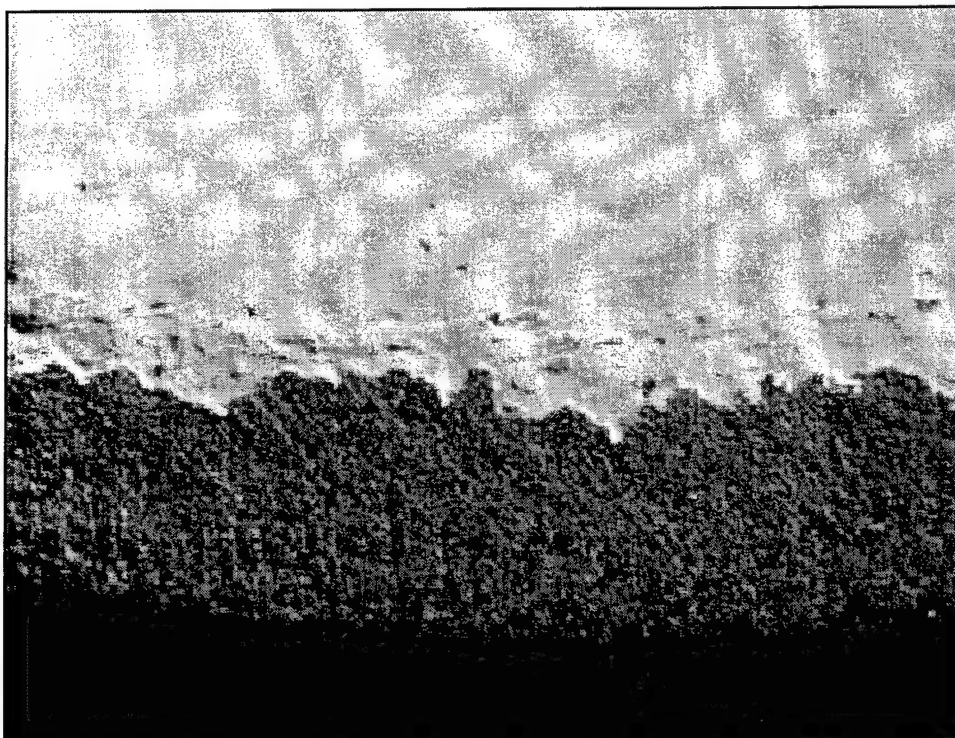
Figure 16. Cross section of chromia coating with 400 series stainless steel interlayer and no seal coat (Specimen 16).

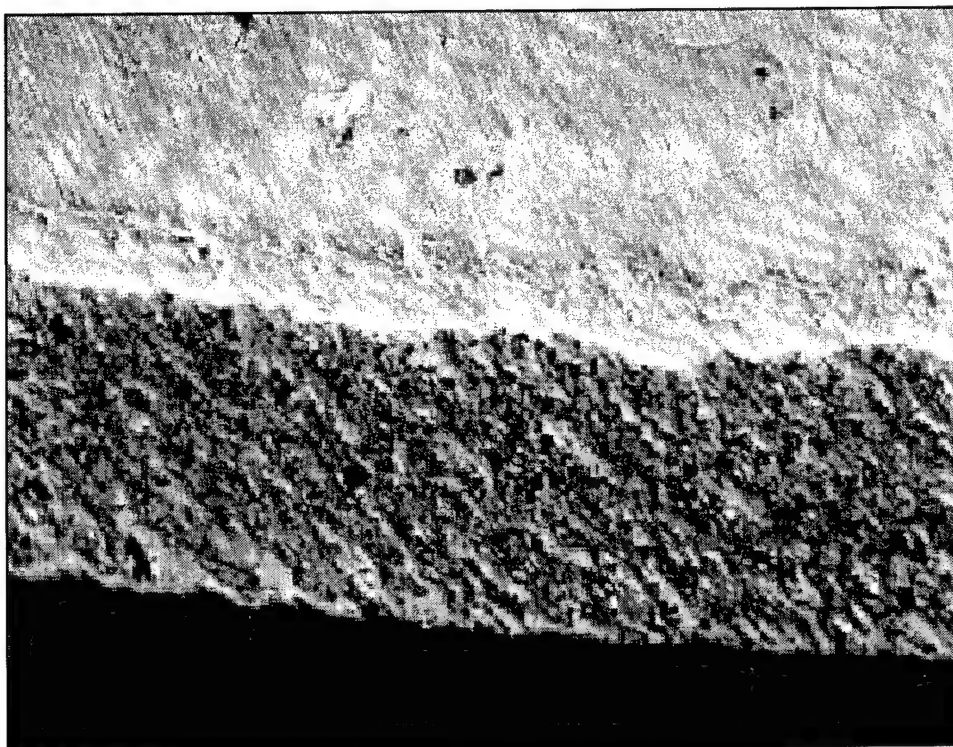
Figure 17. Cross section of alumina-40% titania coating with molybdenum interlayer and no seal coat (Specimen 17).

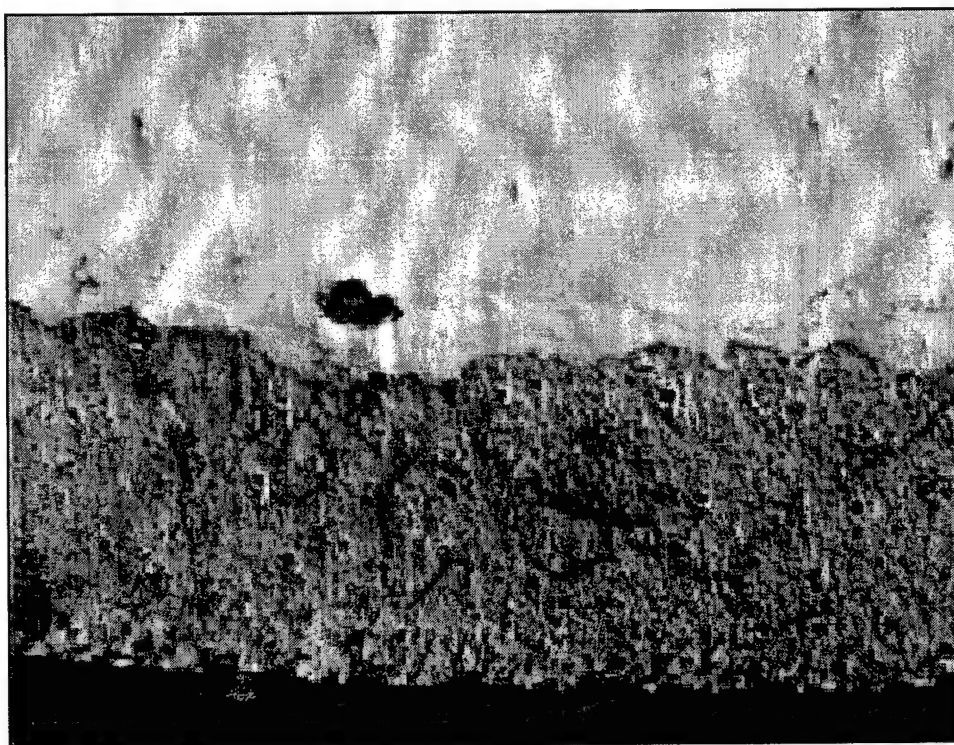
Figure 18. Cross section of titania coating with nickel-chrome interlayer and seal coat (Specimen 18).

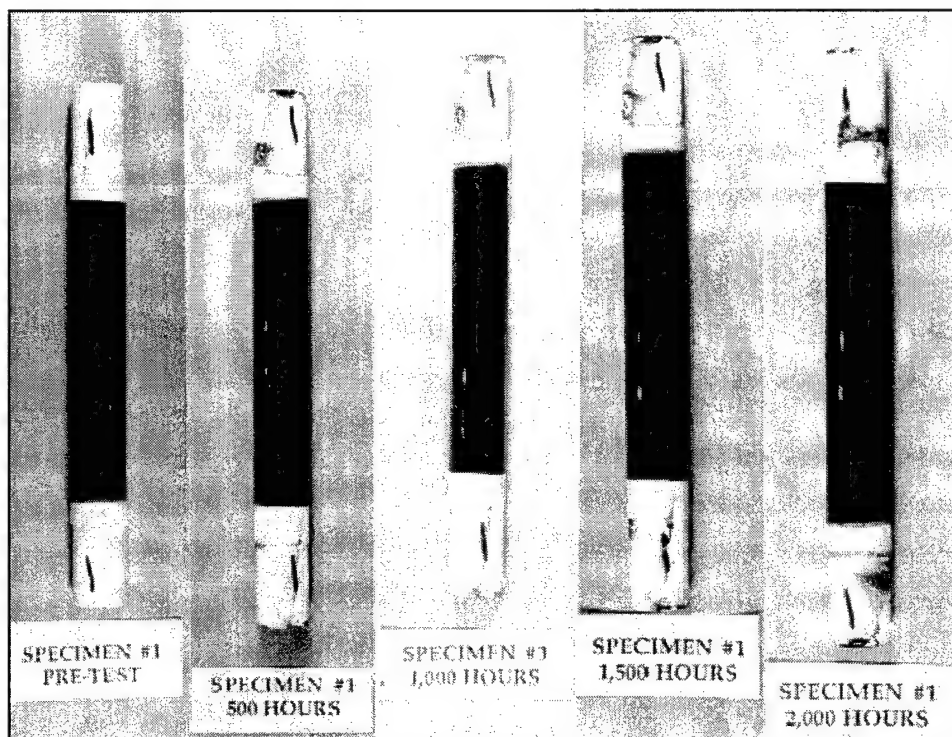
Figure 22. Specimen #1 showing the results of the salt spray test.

Table 3 lists the observations from the salt fog test. Specimens 1, 5, 6, 12, 13, 15, and 19 are free from any corrosion of the substrate. Specimen 7 showed some dulling of the gloss and the remainder have varying degrees of cracking and spalling of the coating. Specimen 6 is the only one of the group that survived the salt spray test for 2,000 hours that had a seal coat. Specimens 1, 5, 6, and 19 had bond coats of nickel-chrome applied with plasma spray. Specimens 12 and 13 had nickel-aluminum bond coats applied by HVOF and arc spray, respectively. Specimen 15 had a 316 stainless steel bond coat applied with plasma spray. Specimen 7 had no bond coat and had a topcoat of Chromia. The substrate of the failed specimens had corroded under the ceramic coating. The corrosion started as a spot and grew until the corrosion products expanded sufficiently to cause the coating to crack in most cases. Figure 22 shows the stages of the test for

sample 1. Figure 23 shows the stages of the test for sample 9. These two figures are typical of the test specimens that passed and failed, respectively, from the salt spray test.

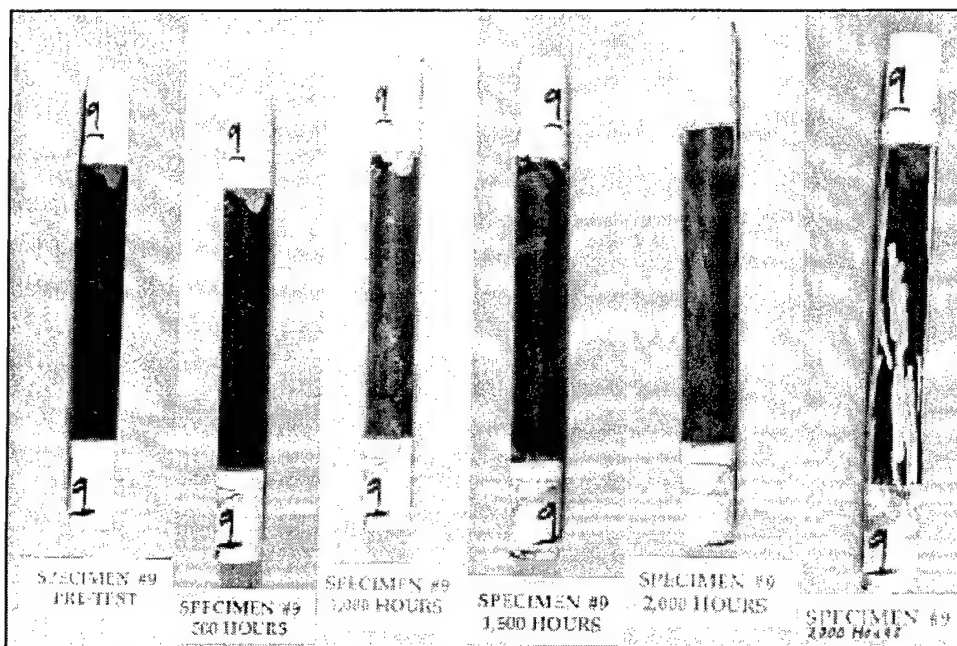
Figure 23. Specimen #9 showing the results of the salt spray test; the last frame shows the cracks outlined in white.

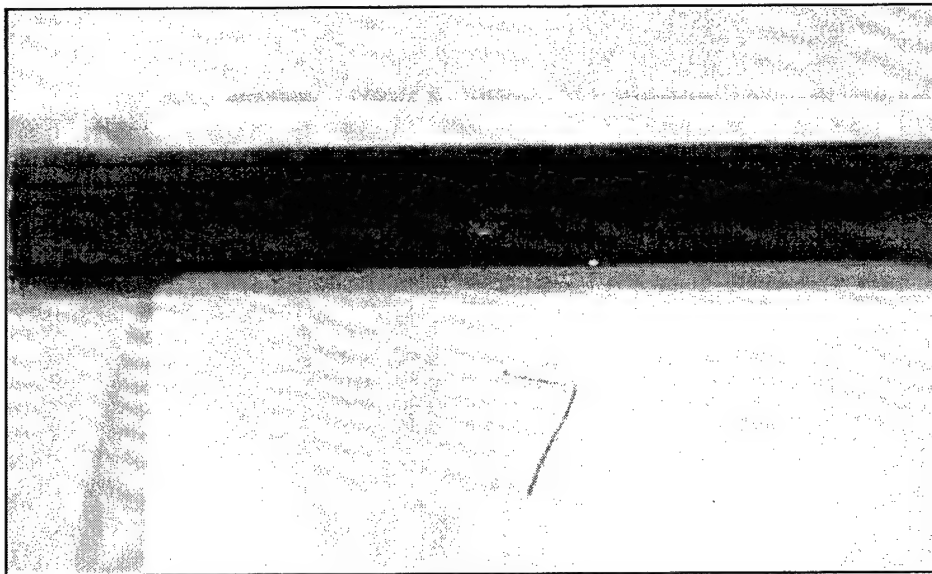
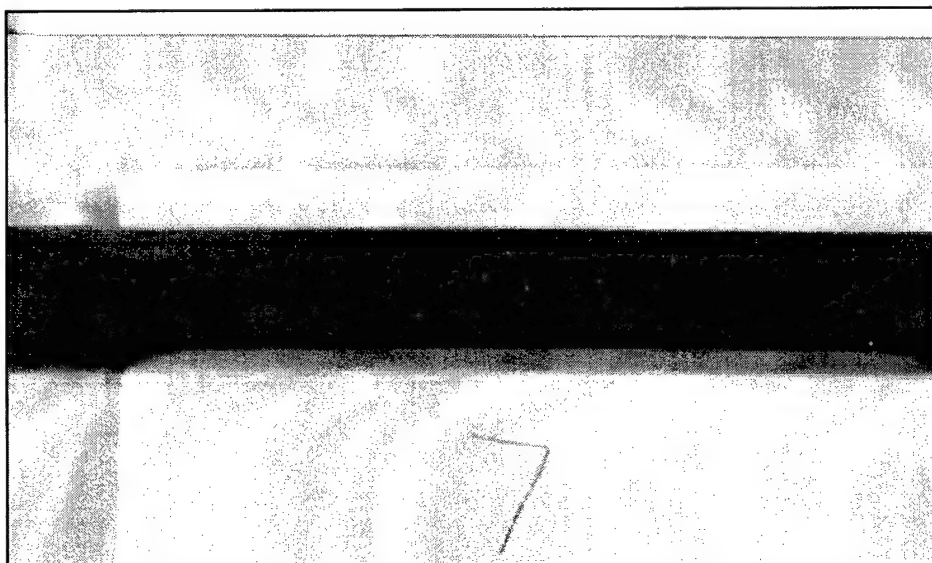
Figure 24. Specimen #7 bend test sample showing compression side (top) and tension side (bottom).

Specimens 1, 5, 6, 12, 13, 15, and 19 are free from any corrosion of the substrate from the salt spray test. Specimens 7 and 16 showed the best results with no cracks appearing on the tension side during the three-point bend test. Specimens 1, 3, 7, 18, and 21 had minimal cracking as a result of the 5 in.-lb impact. Specimens 4, 12, 13, 15, and 21 had no spalling and only some cracking at the 15 in.-lb energy level. None of the samples met the impact criteria of 5 to 17 ft-lb impact loading without damage. All of the specimens had some type of damage from the impact of the ball on its surface at all energy levels. The brittleness of the ceramic coatings does not allow the material to absorb much energy before it sustains some kind of damage from impact. Overall, specimens 15 and 21 did the best in the varying impact loading. Specimen 17 had the lowest hardness number at 81.06, which is equivalent to a Rockwell "C" of approximately 41.5. Specimen 8 had the highest hardness number at 95.06, which is equivalent to a Rockwell "C" of 74. The average hardness for the specimens with the alumina top coating were all within three hardness numbers of each other except sample 17, which had a molybdenum bond coat. The average hardness for specimens with the pure chromia top coat were all within two hardness numbers of each other. The Rexroth samples had a hardness number within the range for the alumina coated samples. Only specimens 7, 8, 9, 10, 11, and 16 had hardness numbers over the minimum Corps requirement. These specimens had the pure chromia topcoat with either no bond coat, a plasma sprayed coating of 400 series stainless steel, or a plasma sprayed nickel-chrome coating.

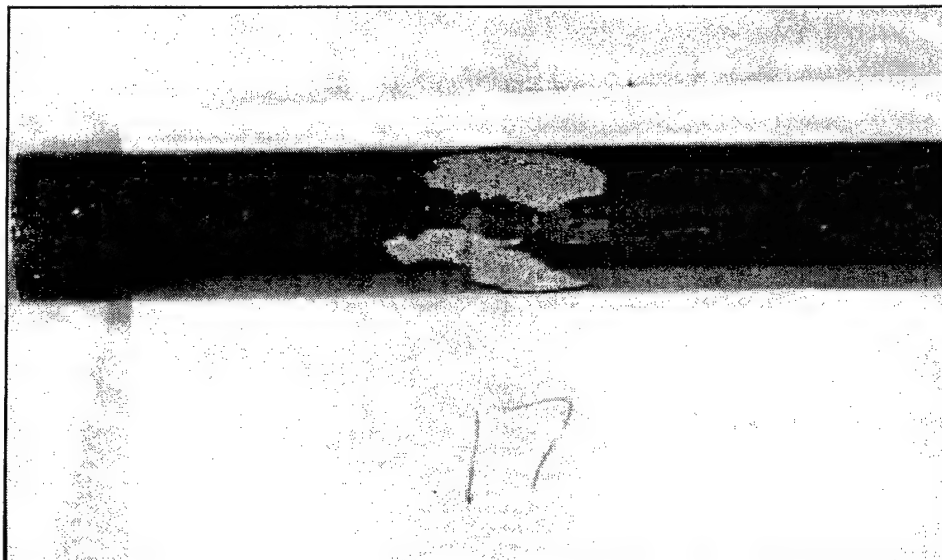
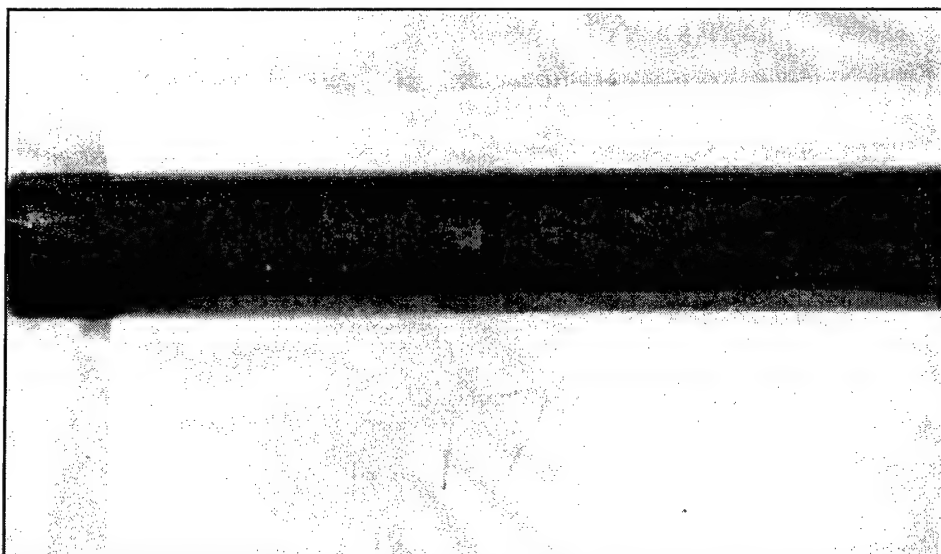
Figure 25. Specimen #17 bend test sample showing compression side (top) and tension side (bottom).

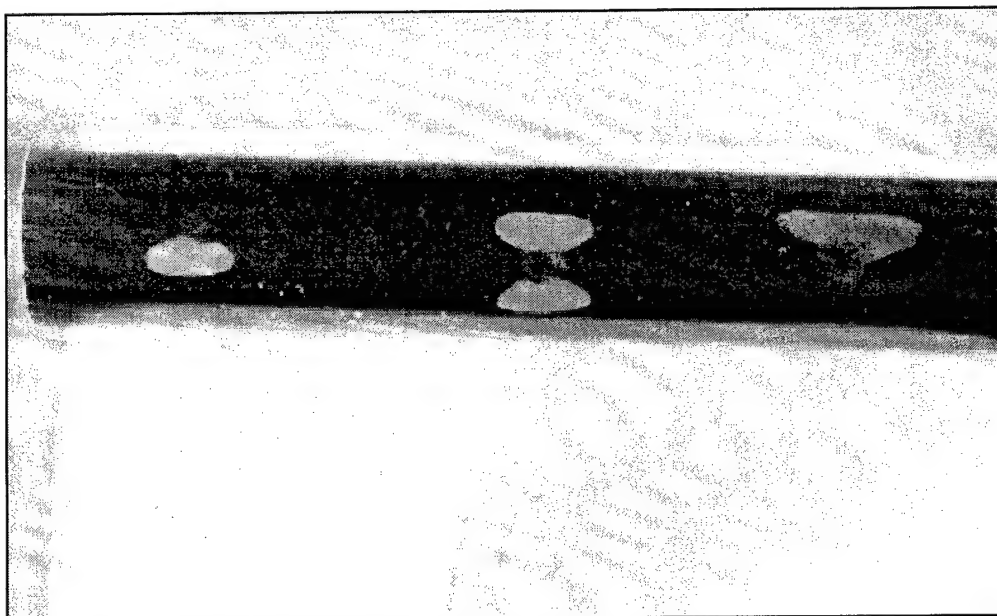
Figure 26. Impact specimen #16 showing results of impact energies of 5, 10, and 15 in.-lb, starting from the left.

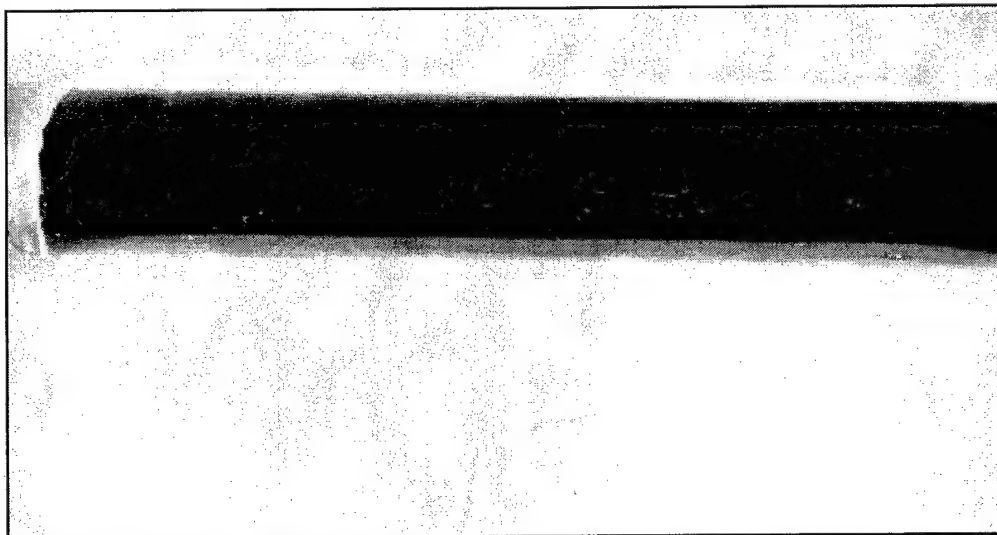
Figure 27. Impact specimen #15 showing results of impact energies of 5, 10, and 15 in.-lb, starting from the left.
